**SERVICE BULLETIN
&
TECHNICAL SERVICE INFORMATION**

**CAPCOM® coin-op, INC.
FIELD SERVICE
3311 N. KENNICOTT AVE.
ARLINGTON HEIGHTS, ILLINOIS 60004**

SERVICE BULLETIN
95-001

GAME: STREET FIGHTER THE MOVIE™

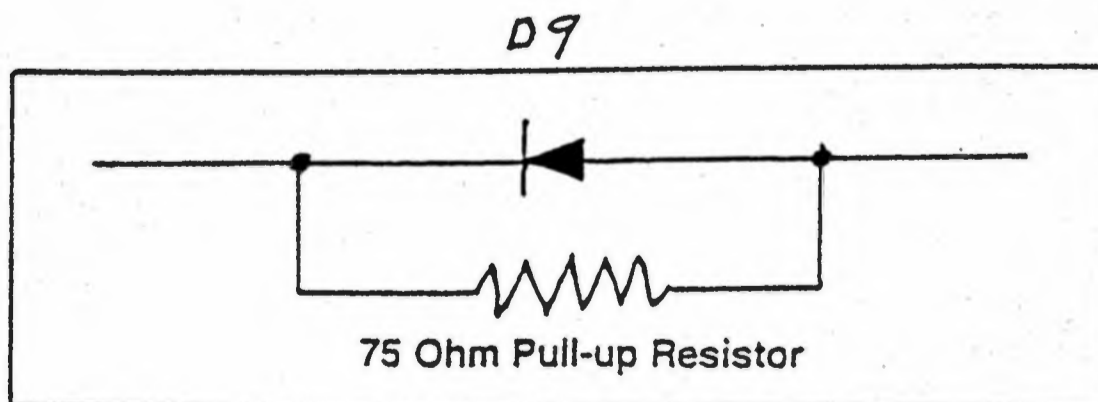
REF: 33" OR LARGER MONITORS

THE PULL-UP RESISTOR WILL PROVIDE THE NECESSARY SYNCHRONIZATION OF THE
VIDEO SIGNAL TO THE MOTHERBOARD.

FOR KIT INSTALLATIONS REQUIRING THE USE OF 33" MONITORS OR LARGER,
A 75 OHM, PULL-UP RESISTOR MUST BE INSTALLED ON THE COMPONENT
SIDE OF THE MOTHERBOARD PCB AS FOLLOWS:

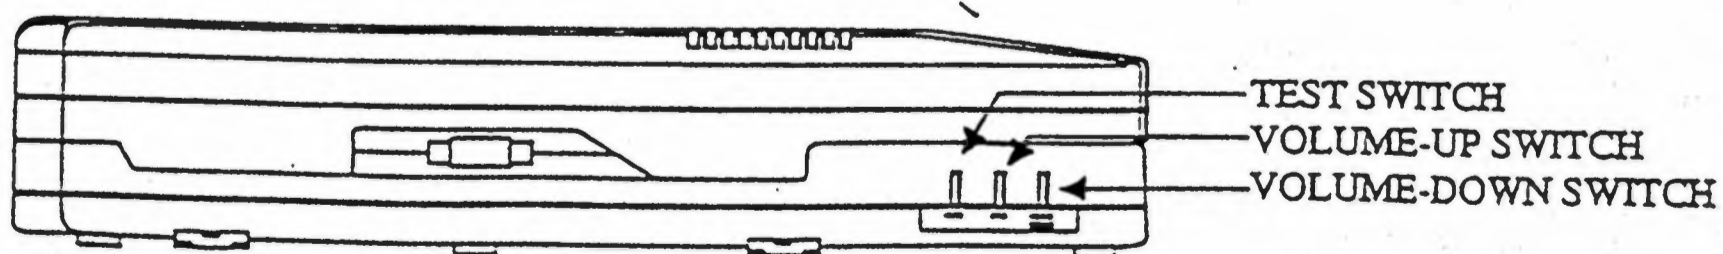
TO CORRECT AUDIO VOLUME PROBLEMS ON ANY CPSII SYSTEM

1. ON THE "A" BOARD, DEPRESS AND HOLD "VOLUME-DOWN" BUTTON AT LEAST 5 SECONDS TO RESET INTERNAL DATA.
2. RELEASE THE "VOLUME-DOWN" BUTTON.
3. ON THE "A" BOARD DEPRESS "VOLUME-UP" BUTTON TO REACH DESIRED VOLUME LEVEL.
4. FOR ANY FURTHER VOLUME SETTING, RECOMMEND USE TO THE "SOUND TEST" IN THE "TEST MENU"

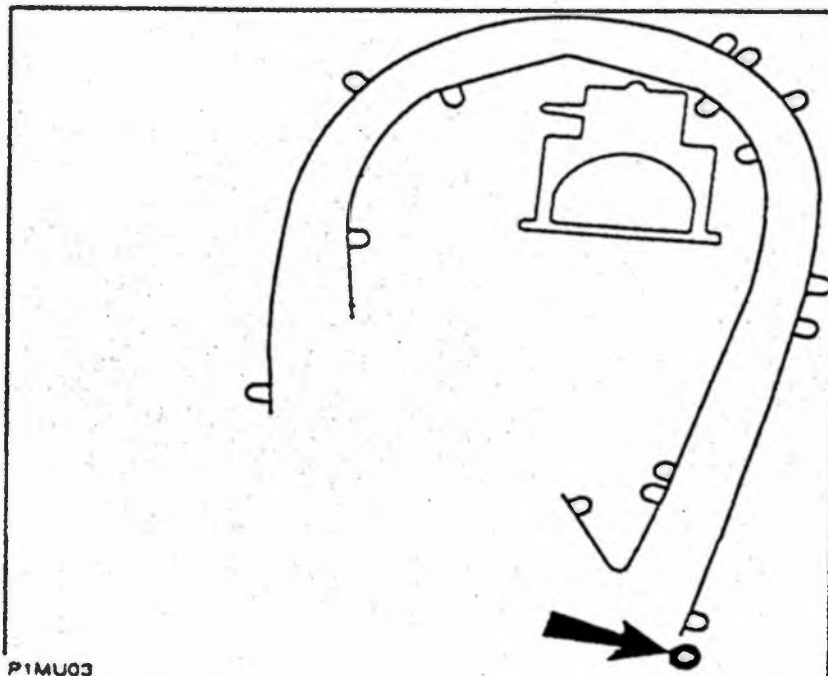
SUBJECT: BALL DRAIN WHEN EXITING ORBIT SHOT

REASON FOR BULLETIN: BALL DEFLECTS OFF OF RUBBER BUMPER WHEN EXITING ORBIT.

WHEN SHOOTING THE ORBIT SHOT FROM LEFT TO RIGHT, THE BALL SHOULD HIT THE RIGHT SIDE FLIPPER BAT. IF THE BALL EXITS BETWEEN THE TWO FLIPPERS CHECK, TO SEE IF THERE IS A RUBBER BUMPER ON THE POST AT THE EDGE OF THE ORBIT SHOT. SEE ARROW IN DRAWING BELOW:

"IF THERE IS A BLACK RUBBER BUMPER ON THIS POST." REMOVE SCREW IN PLASTIC TO THE REAR OF THE TOP HAT. FLEX PLASTIC AND REMOVE RUBBER BUMPER. REINSTALL SCREW.
